# **Mobile Intel<sup>®</sup> Celeron<sup>™</sup> Processor at 466 MHz, 433 MHz, 400 MHz, 366 MHz, 333 MHz, 300 MHz, and 266 MHz Specification Update**

Release Date: August 2001

Order Number: 244444-026

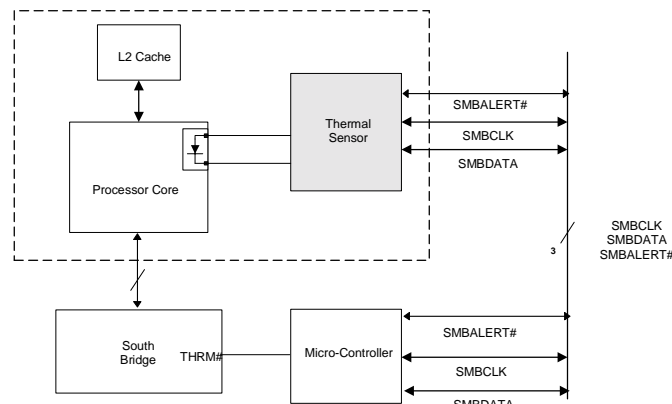
### Figure 1. An Example of Microcontroller Driven Thermal Management

## H29. Thermal Sensor May Assert SMBALERT# Incorrectly

**Problem:** The Intel Celeron Processor Mobile Module has a thermal sensor that monitors the processor core's temperature. Please note that desktop systems could have a similar thermal device. The thermal sensor asserts SMBALERT# if the processor temperature exceeds the temperature limits set in the Alarm Threshold Registers (T<sub>HIGH</sub>, T<sub>LOW</sub>). It also sets the corresponding Status Register bits to identify the cause of the interrupt. Figure 1 gives one example of the how the SMBALERT# signal could be used in a system.

**Implication:** There is no system impact from this erratum if temperature polling is used for processor thermal management. If the SMABLERT# interrupt is employed to manage processor thermal sensing, then servicing the false interrupt may result in premature system action depending on the software and hardware implementations used. The rate of the false interrupts is less than the auto-convert rate of the thermal sensor.

**Workaround:** Three different (mutually exclusive) workarounds are possible:

1. Before servicing an interrupt from the thermal sensor, read and compare the processor thermal reading with the threshold limits ( $T_{HIGH}$  or  $T_{LOW}$ ). Figures 2 and 3 provide basic flowcharts for the implementation of this workaround in an interrupt driven system.
2. If the firmware implemented polls the Status Register only, then before taking any action, re-read the temperature register and do a comparison with the alarm threshold limits ( $T_{HIGH}$  or  $T_{LOW}$ ) to determine if the value is actually still within the temperature window.
3. Use a temperature polling scheme to monitor the processor temperature.

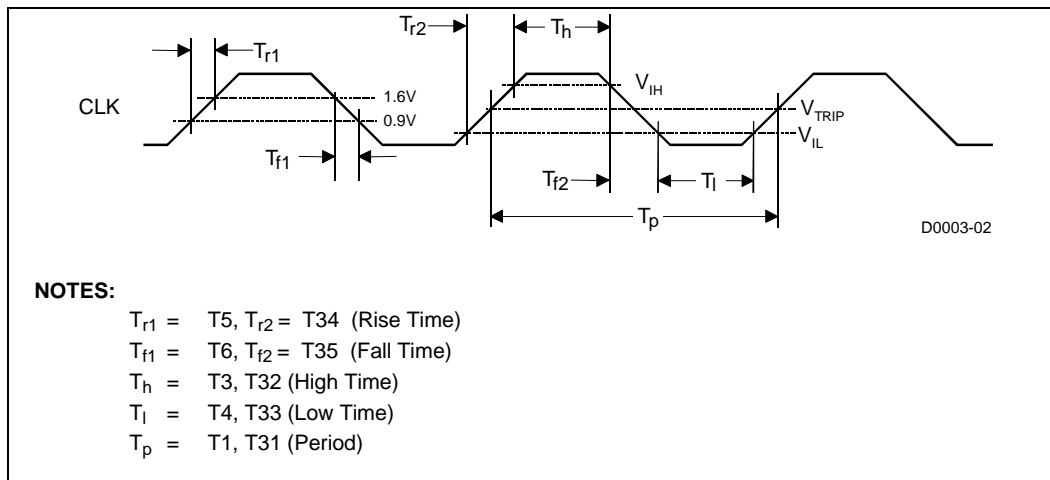
Figure 3.3 Generic Clock Waveform

## H11. Generic Clock Waveform Figure

Figure 3.3 in the *Intel® Mobile Celeron™ Processor in  $\mu$ PGA1 and BGA1 Packages at 366 MHz, 333 MHz, 300 MHz, and 266 MHz* datasheet (Order Number 245112-003) has been updated. The following figure is to replace the one in the above document.
